Corrosion in the Petroleum Industry

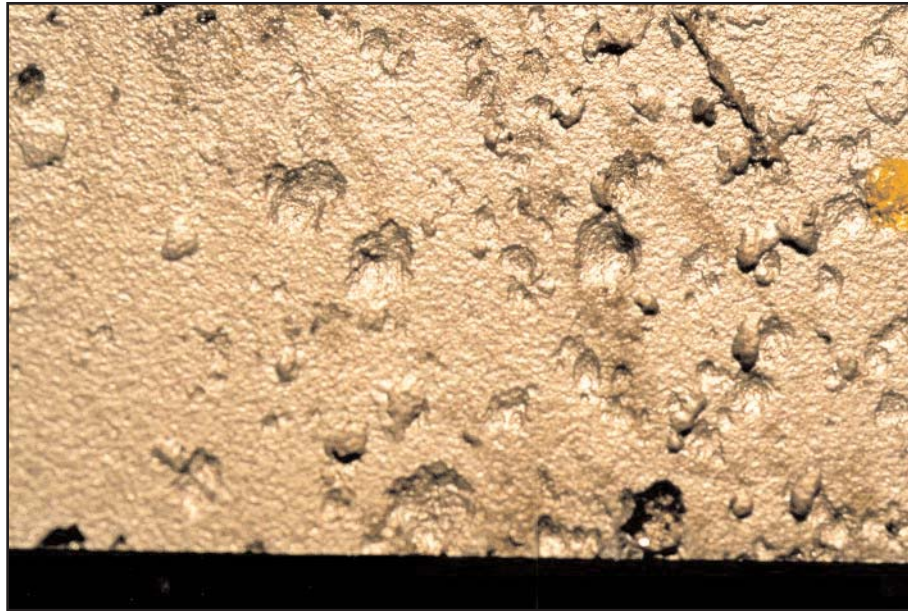
Numerous fissures and cracks formed in the dome of the degasifier section of a deaerator, requiring replacement of the entire dome (Figure IX-14). The system was shut down for four weeks before failure, during which time the deaerator was kept hot with steam feed. No failures occurred when the unit was restarted. However, after four days of operation several cracks penetrated through the dome. The internal surface was also covered with substantial amounts of iron oxide corrosion products that formed in place. These corrosion products overlaid shallow depressions (Figure IX-15).

Figure IX-15: Iron Oxide Corrosion Products Removed to Reveal Depressions

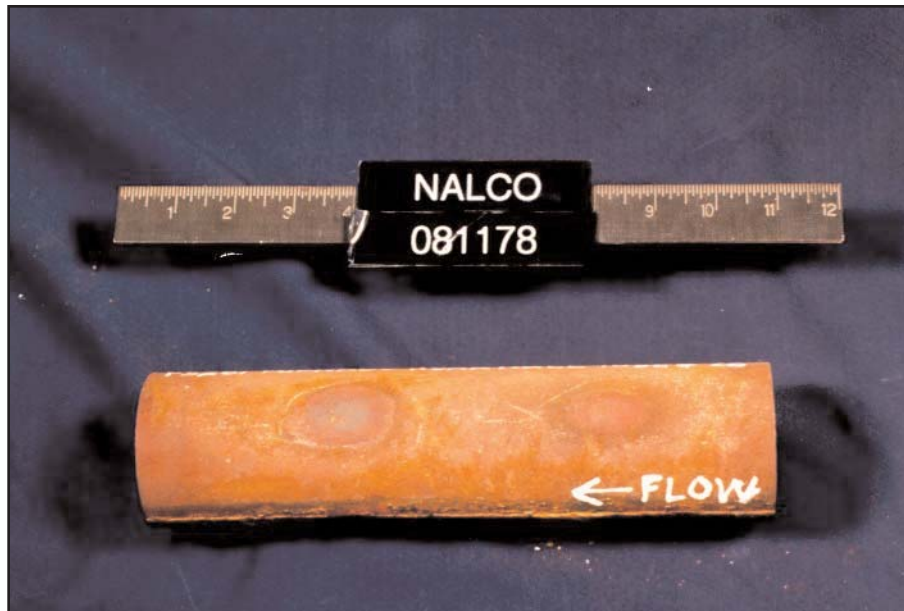
Two bulges formed within a localized area on the hot side of a boiler wall tube (Figure IX-17). The bulges occurred in a tube that was located near a burner. Internal deposition was light in all areas except at the bulges (Figure IX-18).

Figure IX-17: Localized Bulges on Hot Side of Wall Tube

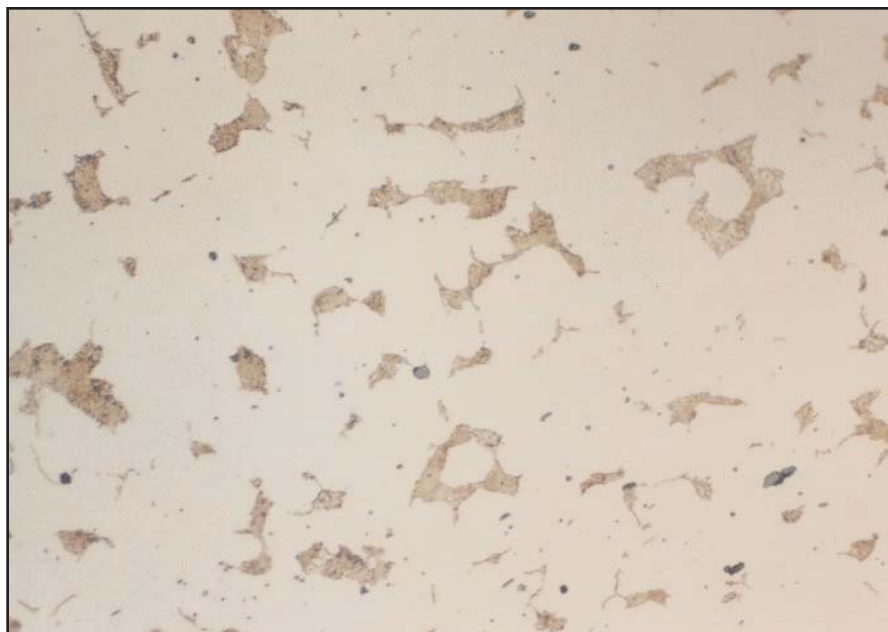
Metallographic analysis indicated that the original pearlite microstructure of the tube was maintained in all locations except the bulges (Figure IX-19). At the bulges, the microstructure changed to scattered spheroidal carbides in a ferrite matrix (Figure IX-20). Creep fissures also formed on the bulge external surfaces (Figure IX-21). Moderately thick layers of thermally-formed iron oxide built up on both internal and external surfaces at the bulges.

Figure IX-19: Microstructure of Tube in As-manufactured Condition in All Locations Except at Bulges Consisting of Colonies of Pearlite in Ferrite Matrix

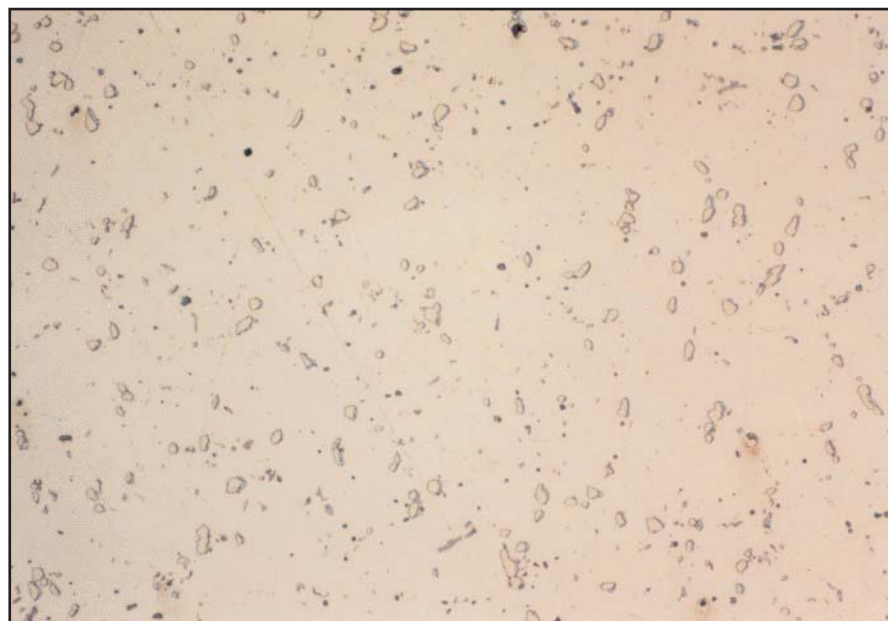
Figure IX-20: Microstructure at Bulges Consisting of Spheroidal Carbides in Ferrite Matrix

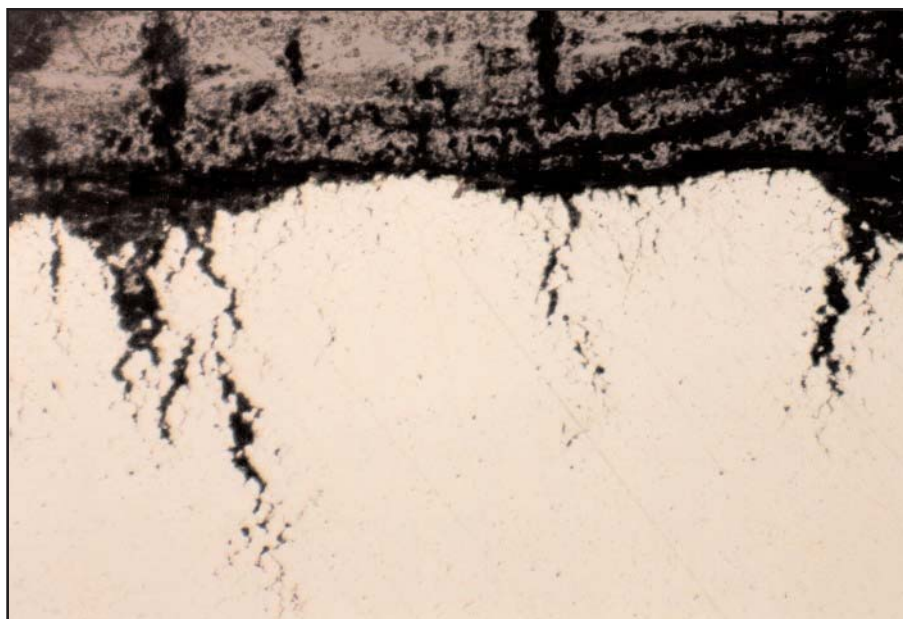
Figure IX-21: Intergranular Creep Fissures on External Surface at Bulge

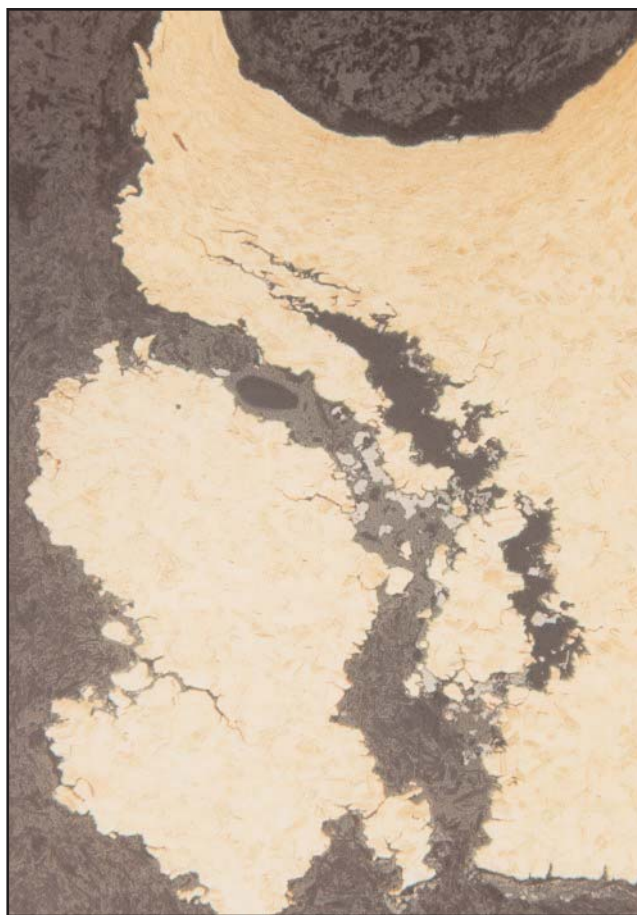
Figure IX-28: Branched, Intergranular Crack and Fissures Penetrating from Internal Surface

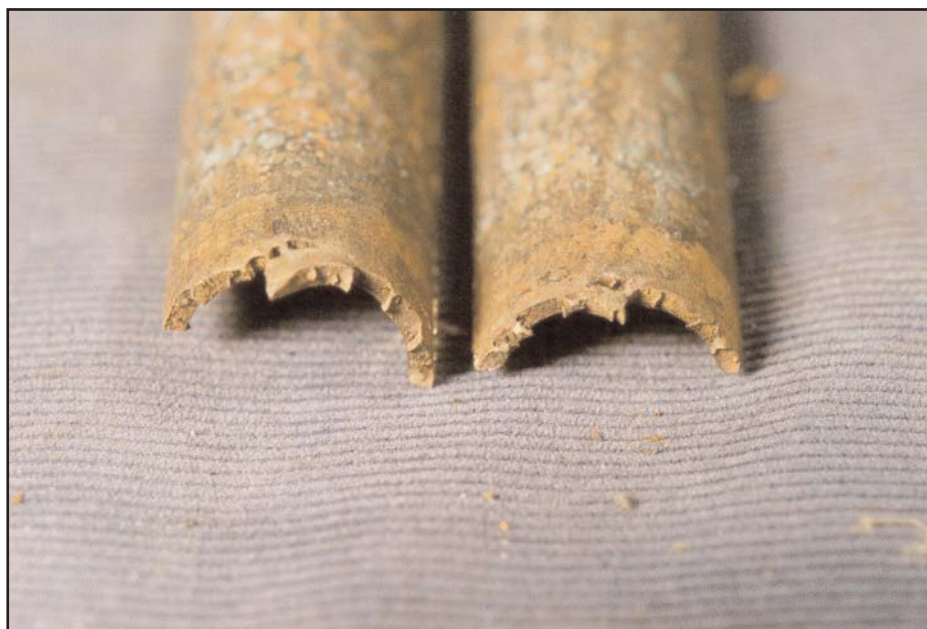
Numerous leaks occurred in the system over a short period of time. The received section contained a thick wall fracture on one end (Figure IX-29). Multiple crack initiation sites were present along the circumference. Numerous tight, transversely oriented cracks and fissures were present on the internal surface near the fractured end (Figure IX-30). Stratified deposit layers covered a smooth surface contour that showed no significant evidence of corrosion on the internal surface.

Figure IX-29: Brittle Fracture Edge Containing Multiple Crack Initiation Sites

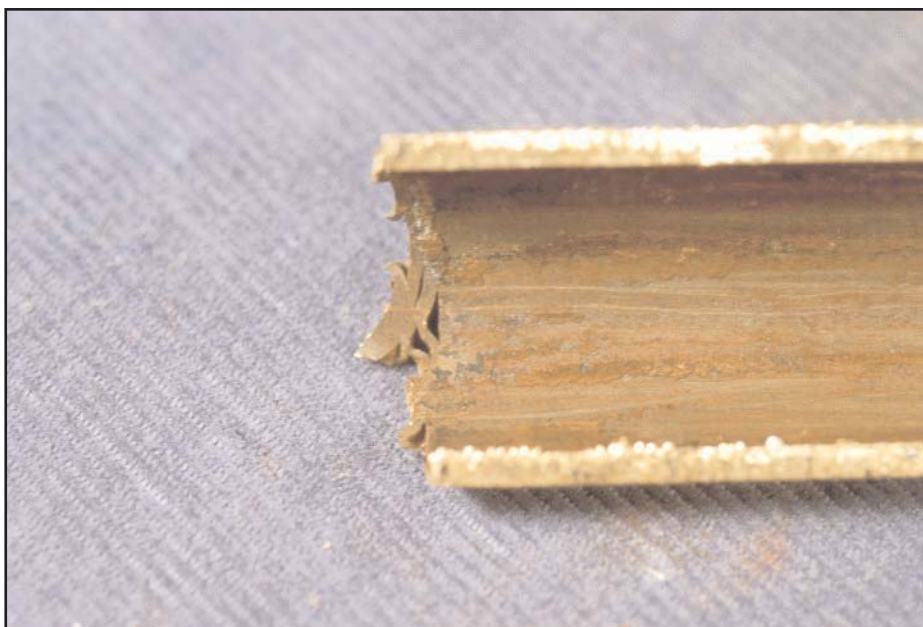
Figure IX-30: Numerous Transversely Oriented Fissures near Fracture Edge

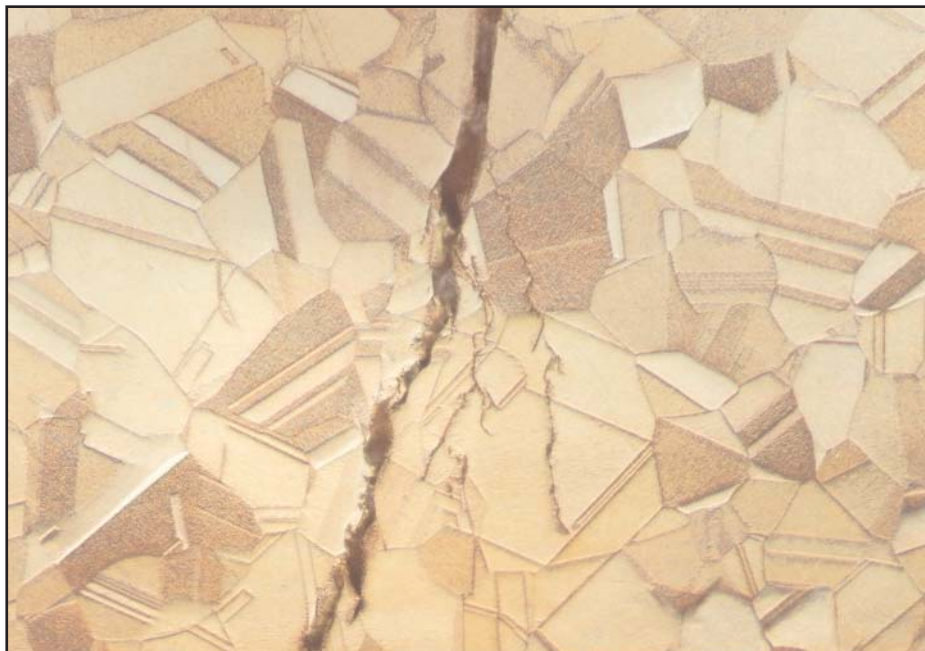
Figure IX-32: Transgranular Propagation Path of a Fissure

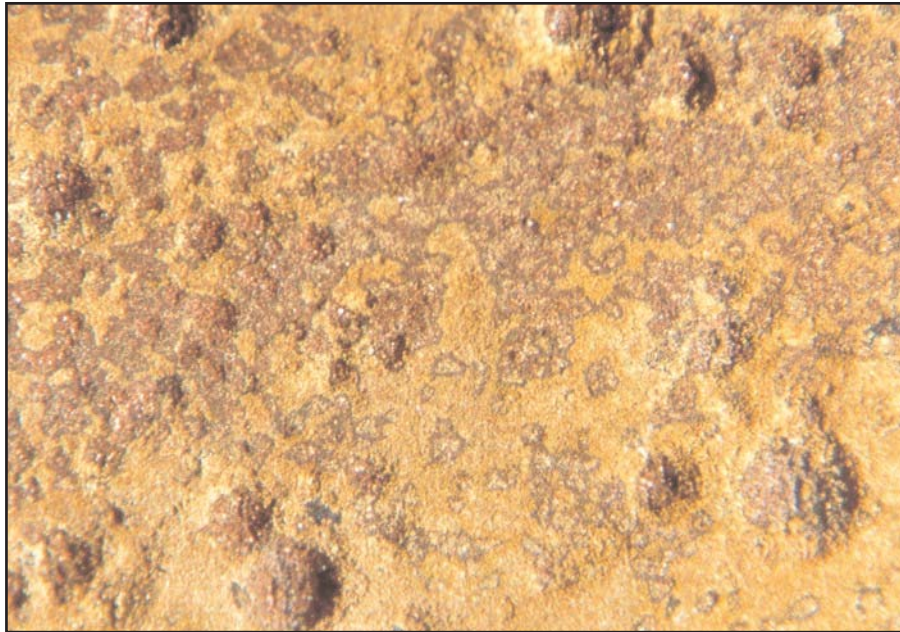
Figure IX-35: Internal Surface Depressions

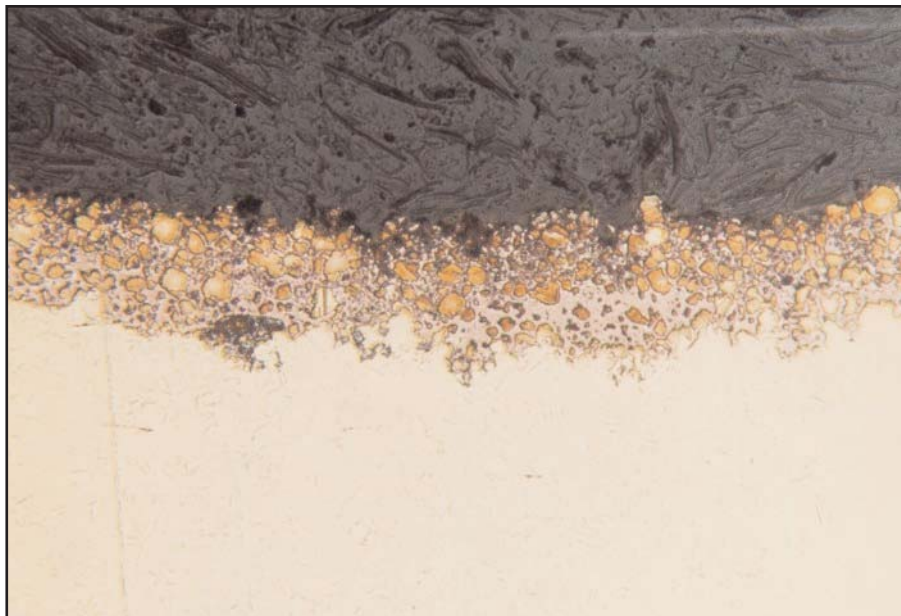
Figure IX-36: Metallic Copper Covering Surface, Indicating Dezincification

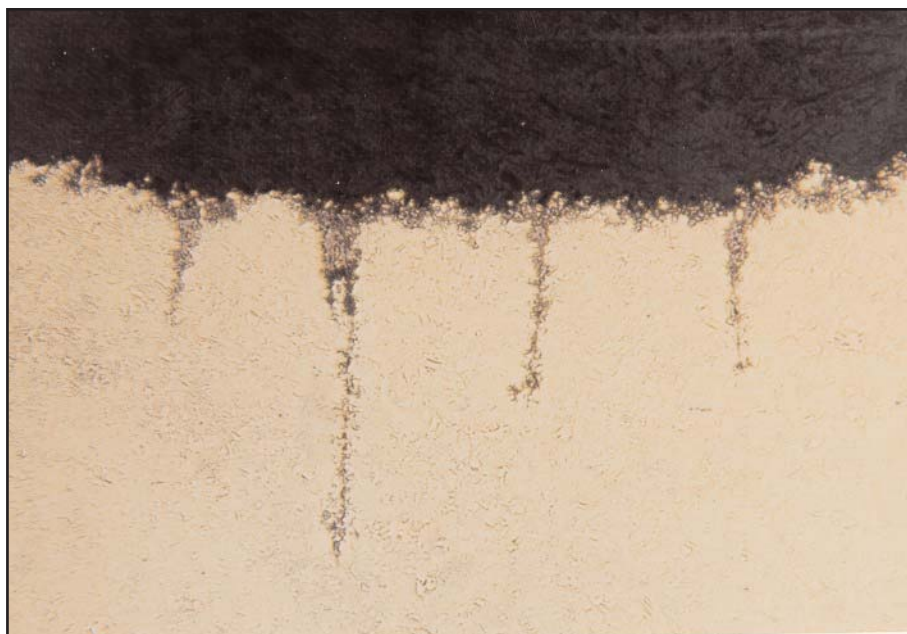
Figure IX-37: Corrosion Fatigue Fissures Penetrating from Base of Depression

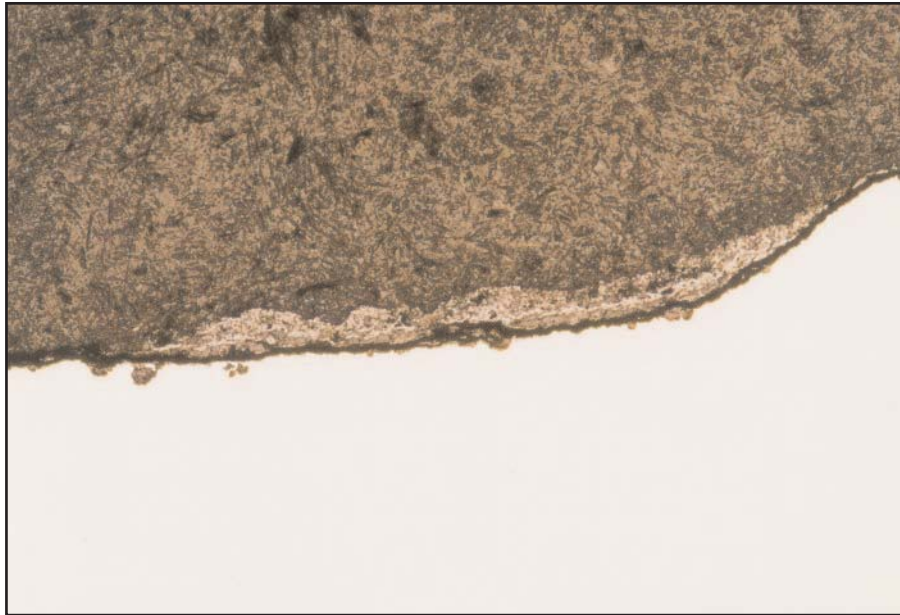
Figure IX-40: Metallographic Cross-section of Depression Covered with Corrosion Products Containing Sulfide

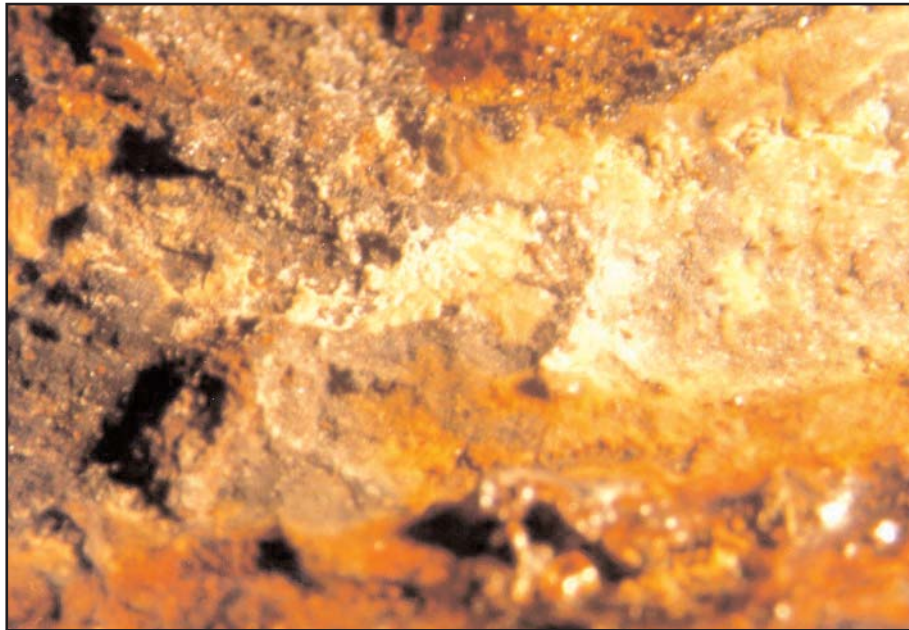
Figure IX-41: Iron Oxide Layers and Tubercles Overlaid with Water-formed Deposit Layers

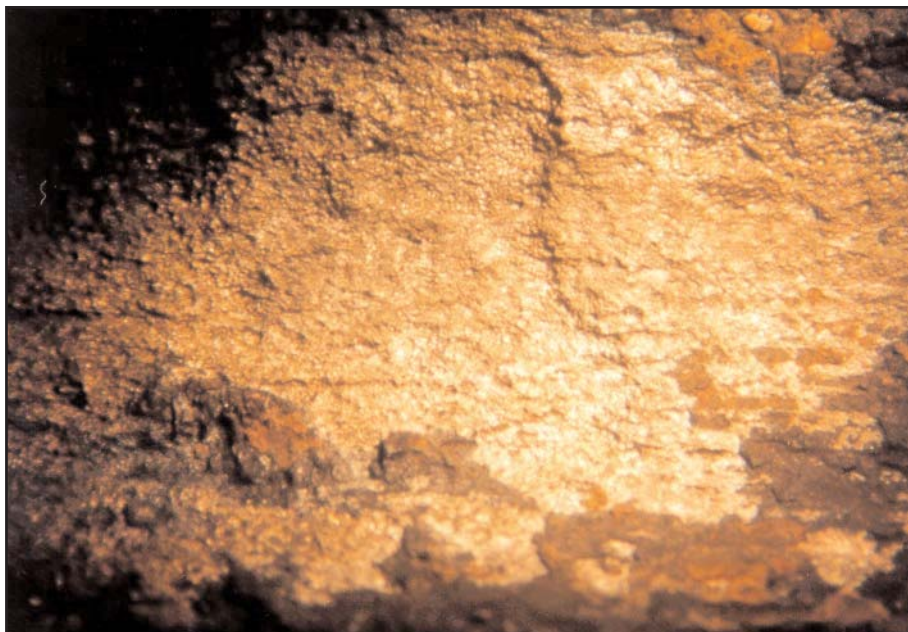
Figure IX-42: Deposit and Corrosion Product Layers Removed to Reveal Rough-surfaced, Undercut Depressions

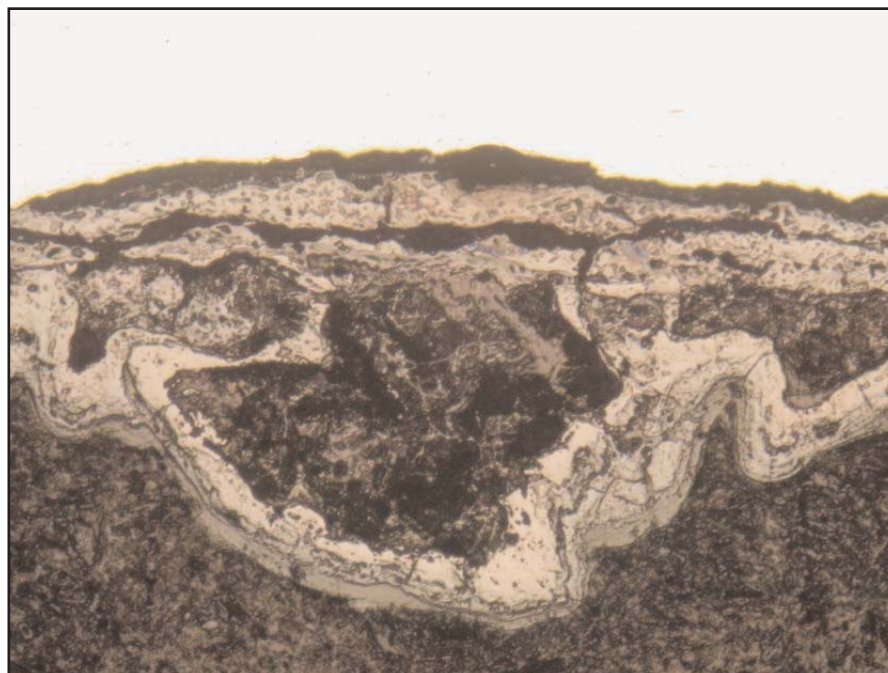
Figure IX-43: Metallographic Cross-section of Rough-surfaced, Undercut Depressions beneath Hollow Iron Oxide Tubercle
